**Flood Control Project Maintenance
Levee Inspections**
LMA District Cover Sheet
Spring 2019 Levee Inspection Results

Reclamation District No. 0524 Middle Roberts Island

Spring 2019 Levee Inspection Results

Waterway			Bank	Unit Miles
Unit No. 01 San Joaquin River			Left	6.20
	Spring (March - May)	Summer (June - August)	(September - November) Fall	Winter (December - February)
Unit Maintenance Rating (Fall Only)				
Date of Inspection	3/26/2019 - 3/27/2019			
DWR Inspector	Alberto De Leon			
Accompanied By	Zach Jojola DWR

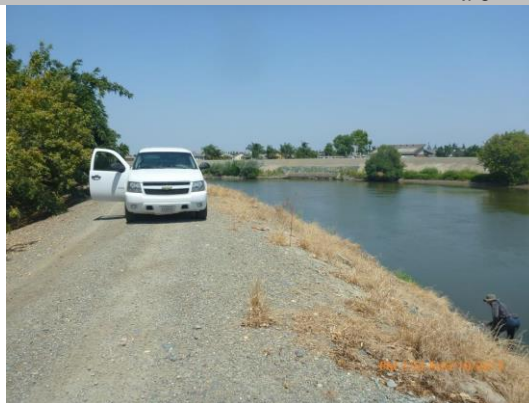
Photo 3 of 3 : LEVAL_SP_2019_525_4208.jpg

LM Start	3.56	Rating **	A/W	Issue No.	234 (cont)
LM End	3.57	Issue Type +	Ma	Location *	
Category	Supplemental			GPS Latitude/Longitude	
				Start	End
Item	2017 Storm Damage			37.904900 °	37.904800 °
				-121.323900 °	-121.324100 °
DWR ID	DWR_RD0524_01_f_2017_234				
Comment Code					
Inspector Comment					
Levee Evaluation Comments					
Description:Slope protection repairs are needed along the waterside slope due to erosion and riprap displacement from high water. Based upon levee inspections, it was determined the waterside levee slope is eroding, deteriorating, and degrading. The eroded levee sections need to be restored back to design standards to prevent further deterioration and damage.					
Site ID No:525					
Site Designation:LMA-431					
Repair Type: Erosion					
Rating:Area of Concern					
Field Date:8/10/2017					
Notes: No appearance of erosion, continue to monitor

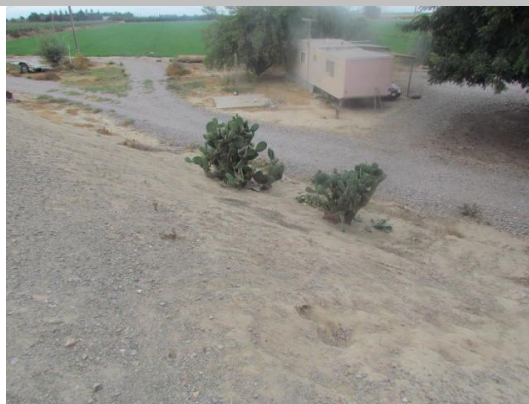
Photo 1 of 1 : SP_2019_RD0524_107_124_20190313_00147.jpg

LM Start	3.61	Rating **	M	Issue No.	124
LM End	3.61	Issue Type +	En	Location *	LS
Category	Earthen Levee			GPS Latitude/Longitude	
				Start	End
Item	Vegetation			37.904375 °	37.904375 °
				-121.324615 °	-121.324615 °
DWR ID	DWR_RD0524_01_f_2012_124				
Comment Code					
V6 : Landscaping					
Inspector Comment					
Landowner planted cactus on landside toe.

Looking west at cactus on landside toe.

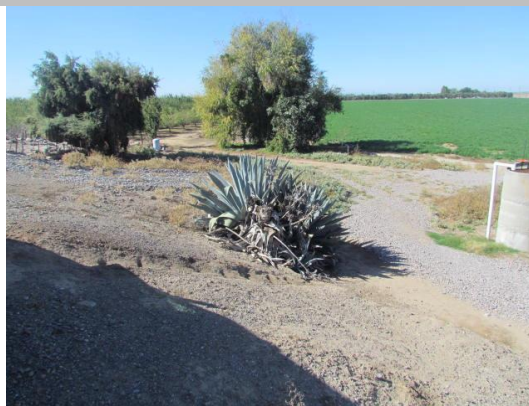
Photo 1 of 1 : SP_2019_RD0524_107_190_20190313_00192.jpg

LM Start	3.65	Rating **	M	Issue No.	190
LM End	3.65	Issue Type +	En	Location *	LS
Category	Earthen Levee			GPS Latitude/Longitude	
				Start	End
Item	Vegetation			37.904070 °	37.904070 °
				-121.325118 °	-121.325118 °
DWR ID	DWR_RD0524_01_f_2015_190				
Comment Code					
V6 : Landscaping					
Inspector Comment					
Large century plant at landside toe.

Looking southwest at century plant at landward toe fall 2015.

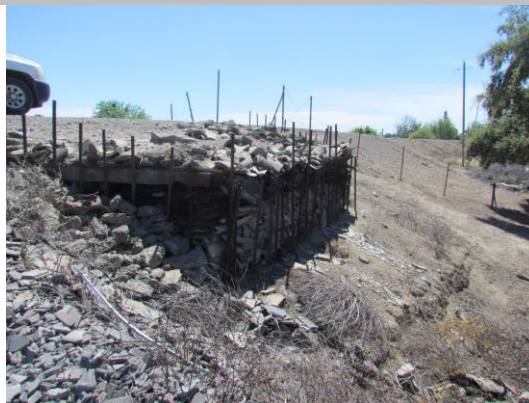
Photo 1 of 1 : SP_2019_RD0524_107_164_20190313_00170.jpg

LM Start	3.66	Rating **	U	Issue No.	164
LM End	3.66	Issue Type +	En	Location *	LS
Category	Earthen Levee			GPS Latitude/Longitude	
				Start	End
Item	Encroachments			37.903983 °	37.903983 °
				-121.325198 °	-121.325198 °
DWR ID	DWR_RD0524_01_s_2017_164				
Comment Code					
BU : Building					
Inspector Comment					
Abandoned deck on landside shoulder.

Looking south at abandoned deck on landward shoulder and slope.

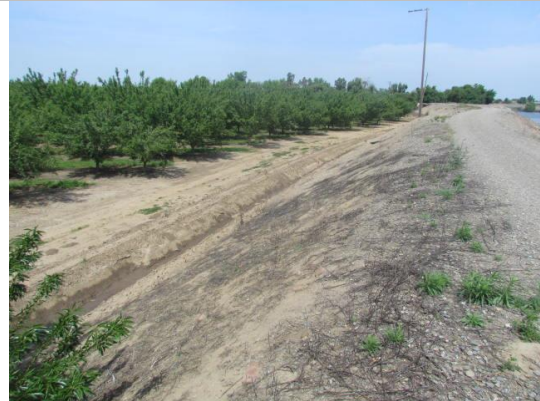
Photo 2 of 2 : SP_2019_RD0524_107_194_20190313_00198.jpg

LM Start	3.69	Rating **	U	Issue No.	194 (cont)	
LM End	3.78	Issue Type +	En	Location *	LS	
Category	Earthen Levee			GPS Latitude/Longitude		
				Start	End	
Item	Encroachments			37.903553 °	37.902505 °	
				-121.325468 °	-121.326425 °	
DWR ID	DWR_RD0524_01_s_2015_194					
Comment Code						
DT : Ditch						
Inspector Comment						
Shallow Irrigation ditch at landside toe.

Looking east at south end of irrigation ditch at landward toe.

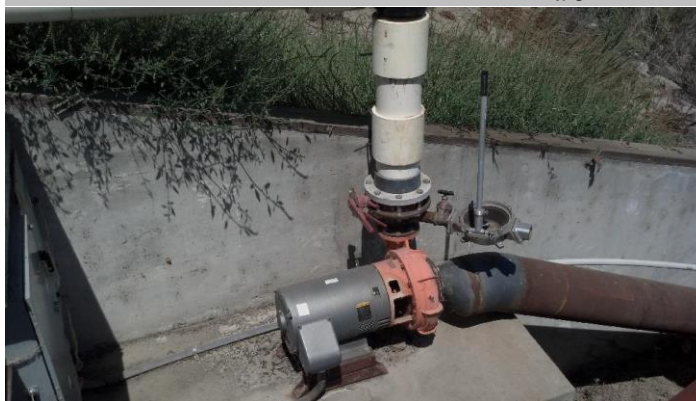
Photo 1 of 3 : UCIP_SP_2019_22725_38445.jpg

LM Start	3.79	Rating **	M	Issue No.	953
LM End	3.79	Issue Type +	En	Location *	
Category	Supplemental			GPS Latitude/Longitude	
				Start	End
Item	DWR UCIP Field Study			37.902371 °	37.902371 °
				-121.326440 °	-121.326440 °
DWR ID	24044				
Comment Code					
Inspector Comment					
FS_ID:22725					
DS_ID:24044					
EP_NO: N/A					
Repair Type: Non-Urgent					
Crossing Status: Found					
UCIP Comments: No permit identified for this crossing.					
FIELD_STRUCT_DESC: 8-inch steel irrigation pipe through the levee, 0 feet below the crown. Pipe integrated into steel cattle guard style crossing. Slant pump and butterfly valve at concrete foundation on the waterside (WS) slope. Filter plant, vents, and butterfly valves on the landside (LS) toe.					
FS Date: 8/20/2013

Pump and butterfly valve on concrete pad on WS shoulder.

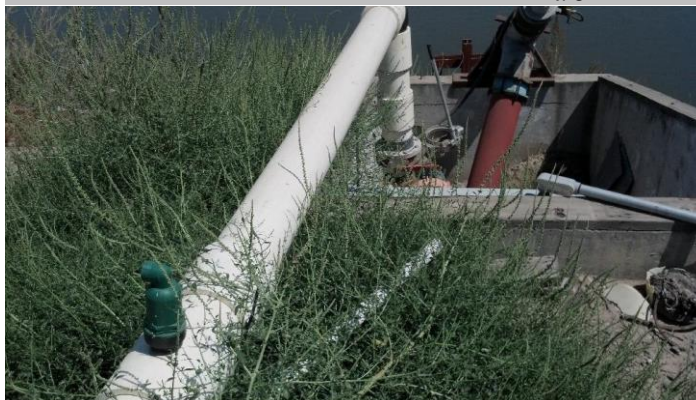
Photo 2 of 3 : UCIP_SP_2019_22725_38444.jpg

LM Start	3.79	Rating **	M	Issue No.	953 (cont)	
LM End	3.79	Issue Type +	En	Location *		
Category	Supplemental			GPS Latitude/Longitude		
				Start	End	
Item	DWR UCIP Field Study			37.902371 °	37.902371 °	
				-121.326440 °	-121.326440 °	
DWR ID	24044					
Comment Code						
Inspector Comment						
FS_ID:22725						
DS_ID:24044						
EP_NO: N/A						
Repair Type: Non-Urgent						
Crossing Status: Found						
UCIP Comments: No permit identified for this crossing.						
FIELD_STRUCT_DESC: 8-inch steel irrigation pipe through the levee, 0 feet below the crown. Pipe integrated into steel cattle guard style crossing. Slant pump and butterfly valve at concrete foundation on the waterside (WS) slope. Filter plant, vents, and butterfly valves on the landside (LS) toe.						
FS Date: 8/20/2013

Vent on PVC pipe at WS shoulder.

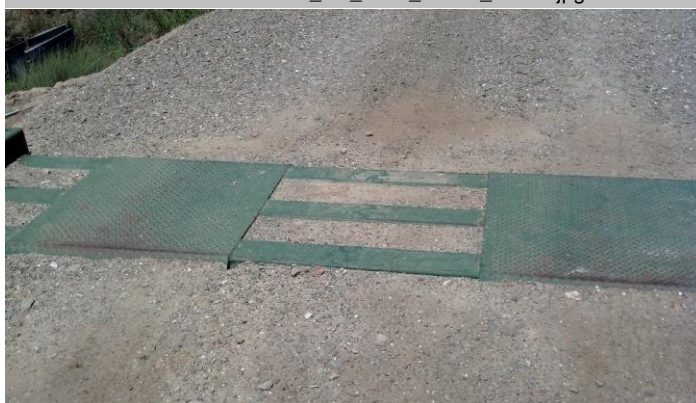
Photo 3 of 3 : UCIP_SP_2019_22725_38443.jpg

Steel, integrated cattleguard style pipe crossing at crown elevation.

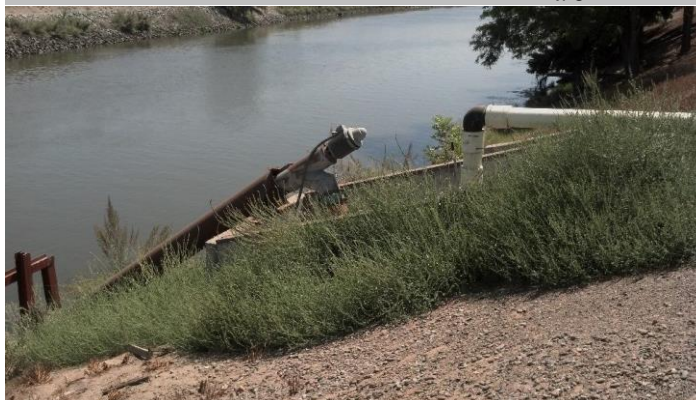
Photo 1 of 3 : UCIP_SP_2019_18307_30528.jpg

Comment Code						
Inspector Comment						
FS_ID:18307						
DS_ID:20620						
EP_NO: N/A						
Repair Type: Non-Urgent						
Crossing Status: Found						
UCIP Comments: Appears abandoned and if so should be done so properly. Evidence of severe internal corrosion in concrete distribution box at LS toe.						
FIELD_STRUCT_DESC: 12-inch concrete encased steel irrigation pipe through the levee, 10.5 feet below the crown. Pump and gate valve in pump house on the waterside (WS) slope. 6-foot by 6-foot Concrete distribution box on the landside (LS) toe. Two concrete cutoff walls. Service pole at the LS toe. [Additional Reference(s): DWR Levee Log, 2004. USACE San Joaquin O&M Manual 7, April 1964, (HLM 3.83)].						
FS Date: 8/20/2013

Slant pump visible at concrete foundation on WS slope. Pumphouse removed.

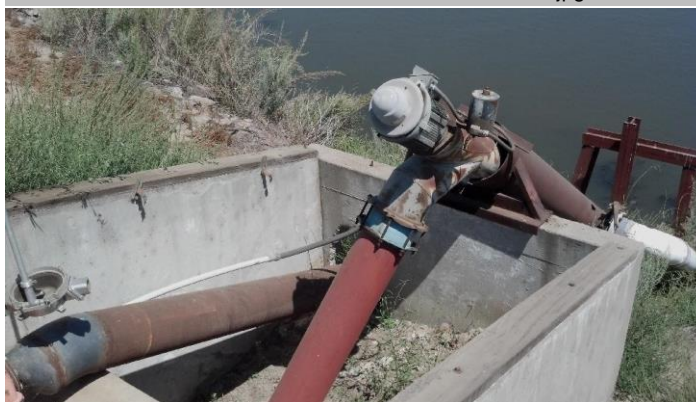
Photo 2 of 3 : UCIP_SP_2019_18307_30527.jpg

Slant pump and pipe on WS slope.

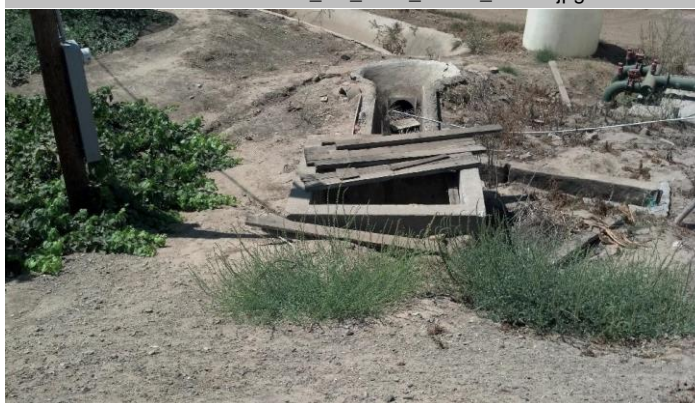
Photo 3 of 3 : UCIP_SP_2019_18307_30526.jpg

Comment Code						
Inspector Comment						
FS_ID:18307 DS_ID:20620 EP_NO: N/A Repair Type: Non-Urgent Crossing Status: Found UCIP Comments: Appears abandoned and if so should be done so properly. Evidence of severe internal corrosion in concrete distribution box at LS toe. FIELD_STRUCT_DESC: 12-inch concrete encased steel irrigation pipe through the levee, 10.5 feet below the crown. Pump and gate valve in pump house on the waterside (WS) slope. 6-foot by 6-foot Concrete distribution box on the landside (LS) toe. Two concrete cutoff walls. Service pole at the LS toe. [Additional Reference(s): DWR Levee Log, 2004. USACE San Joaquin O&M Manual 7, April 1964, (HLM 3.83)]. FS Date: 8/20/2013

6'X6' concrete distribution box and power pole on LS toe.

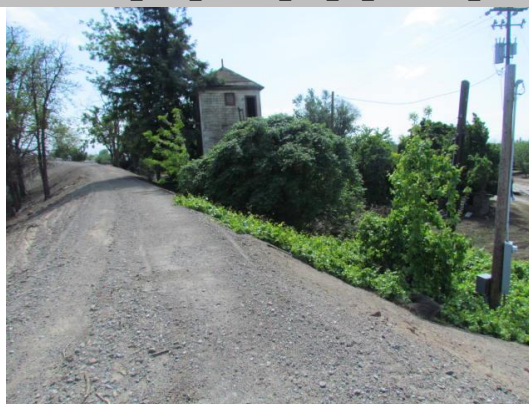
Photo 1 of 2 : SP_2019_RD0524_107_59_20190313_00081.jpg

LM Start	3.79	Rating **	U	Issue No.	59
LM End	3.80	Issue Type +	En	Location *	LS
Category	Earthen Levee			GPS Latitude/Longitude	
				Start	End
Item	Vegetation			37.902287 °	37.902163 °
				-121.326462 °	-121.326476 °
DWR ID	DWR_RD0524_01_s_2012_59				
Comment Code					
V6 : Landscaping					
Inspector Comment					
Downed tree on landward slope.

Looking south at dense veg on landward slope and toe.

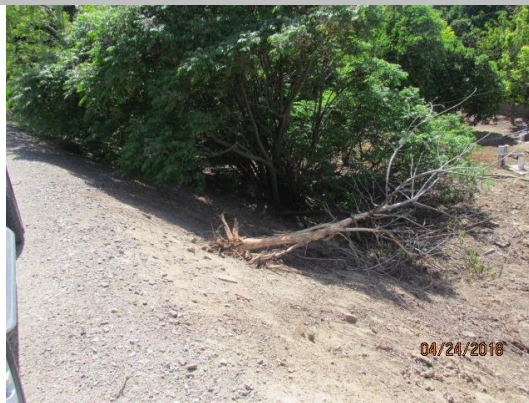
Photo 2 of 2 : SP_2019_RD0524_107_59_20190313_00082.jpg

LM Start	3.79	Rating **	U	Issue No.	59 (cont)	
LM End	3.80	Issue Type +	En	Location *	LS	
Category	Earthen Levee			GPS Latitude/Longitude		
				Start		End
Item	Vegetation			37.902287 °		37.902163 °
				-121.326462 °		-121.326476 °
DWR ID	DWR_RD0524_01_s_2012_59					
Comment Code						
V6 : Landscaping						
Inspector Comment						
Downed tree on landward slope.

Looking at fallen tree on landward slope. (Spring 2018)

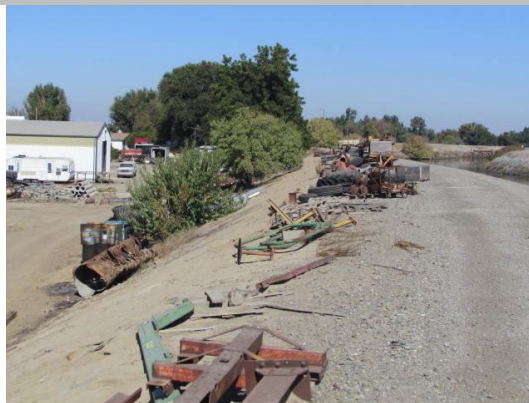
Photo 2 of 3 : SP_2019_RD0524_107_95_20190313_00130.jpg

Looking north at farm equipment stored on landward shoulder.

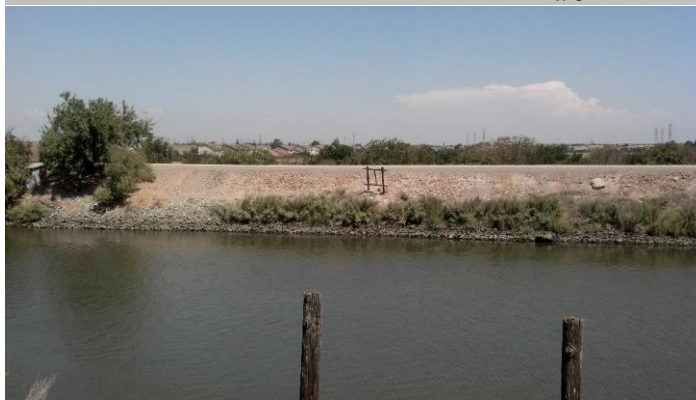
Photo 2 of 2 : UCIP_SP_2019_41464_30542.jpg

LM Start	3.90	Rating **	M	Issue No.	955 (cont)	
LM End	3.90	Issue Type +	En	Location *		
Category	Supplemental			GPS Latitude/Longitude		
				Start	End	
Item	DWR UCIP Field Study			37.900778 °	37.900778 °	
				-121.326420 °	-121.326420 °	
DWR ID	20621					
Comment Code						
Inspector Comment						
FS_ID:41464						
DS_ID:20621						
EP_NO: N/A						
Repair Type: Non-Urgent						
Crossing Status: Found						
UCIP Comments: Appears to be abandoned as signage has been removed.						
FIELD_STRUCT_DESC: 2.5-inch submarine telephone conduit of an unknown material through the levee and across the channel, 2 feet below the crown. Sign posts remain on both sides of the river on the waterside (WS) slope. [Additional Reference(s): DWR Levee Log, 2004].						
FS Date: 8/20/2013

Sign posts visible on opposite river bank in same condition.

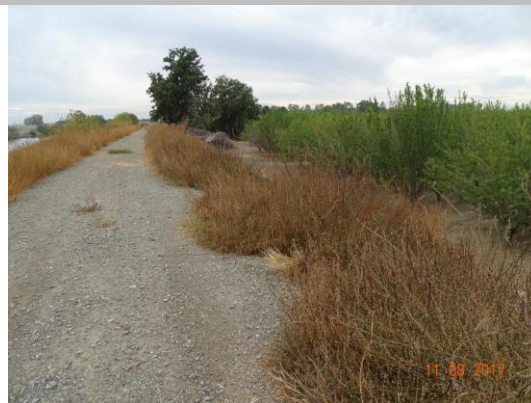
Photo 1 of 1 : SP_2019_RD0524_107_253_20190313_00267.jpg

LM Start	3.97	Rating **	M	Issue No.	253
LM End	4.02	Issue Type +	Ma	Location *	LS
Category	Earthen Levee			GPS Latitude/Longitude	
				Start	End
Item	Vegetation			37.899748 °	37.899116 °
				-121.326596 °	-121.326905 °
DWR ID	DWR_RD0524_01_f_2017_253				
Comment Code					
V2 : Remove the wild growth other than native grasses from the levee slopes.					
Inspector Comment

Looking southwest at the landside slope.

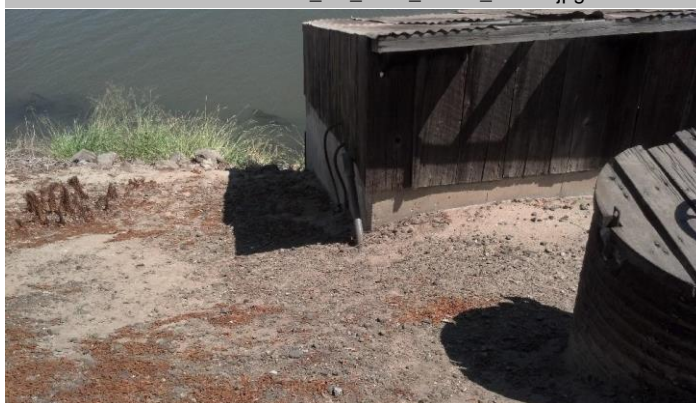
Photo 1 of 3 : UCIP_SP_2019_18314_30559.jpg

Comment Code					
Inspector Comment					
FS_ID:18314					
DS_ID:20623					
EP_NO: N/A					
Repair Type: Non-Urgent					
Crossing Status: Found					
UCIP Comments: Appears abandoned and if so should be done so properly.					
FIELD_STRUCT_DESC: 8-inch concrete encased steel irrigation pipe through the levee, 9.5 feet below the crown. Pump and gate valve in pump house on the waterside (WS) slope. Slide gate in 42-inch corrugated metal pipe riser unit on the WS slope. Brick standpipe at the toe of the landside (LS) slope. 1.5-inch galvanized iron electrical conduit through the levee, 3 feet below the crown at the same location.					
[Additional Reference(s): DWR Levee Log, 2004. USACE San Joaquin O&M Manual 7, April 1964, (HLM 4.08)].					
FS Date: 8/20/2013

Electrical conduit visible on WS slope at pumphouse.

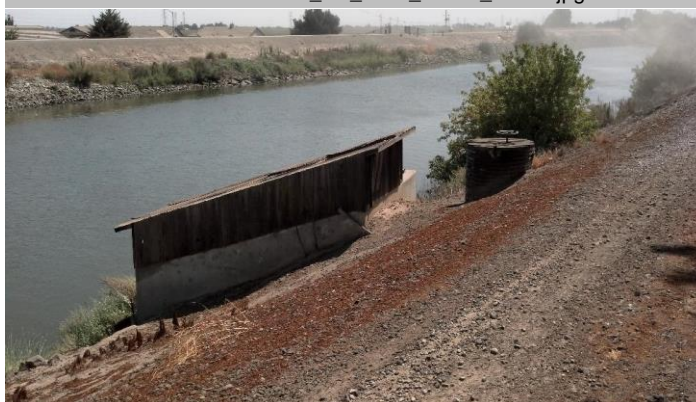
Photo 2 of 3 : UCIP_SP_2019_18314_30561.jpg

Pumphouse and gate valve in CMP riser on WS slope.

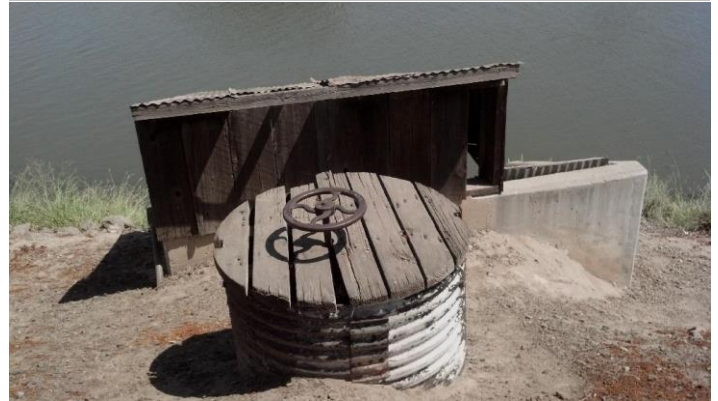
Photo 3 of 3 : UCIP_SP_2019_18314_30560.jpg

Comment Code						
Inspector Comment						
FS_ID:18314						
DS_ID:20623						
EP_NO: N/A						
Repair Type: Non-Urgent						
Crossing Status: Found						
UCIP Comments: Appears abandoned and if so should be done so properly.						
FIELD_STRUCT_DESC: 8-inch concrete encased steel irrigation pipe through the levee, 9.5 feet below the crown. Pump and gate valve in pump house on the waterside (WS) slope. Slide gate in 42-inch corrugated metal pipe riser unit on the WS slope. Brick standpipe at the toe of the landside (LS) slope. 1.5-inch galvanized iron electrical conduit through the levee, 3 feet below the crown at the same location.						
[Additional Reference(s): DWR Levee Log, 2004. USACE San Joaquin O&M Manual 7, April 1964, (HLM 4.08)].						
FS Date: 8/20/2013

Pumphouse and gate valve in CMP riser on WS slope.

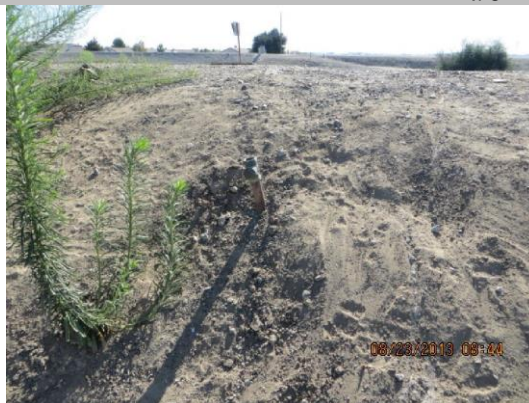
Photo 2 of 3 : UCIP_SP_2019_18318_30588.jpg

Vent or siphon breaker just off LS shoulder.

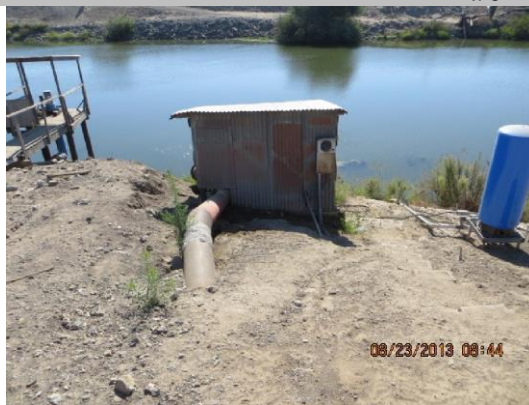
Photo 3 of 3 : UCIP_SP_2019_18318_30587.jpg

Pumphouse and pipe on WS slope.

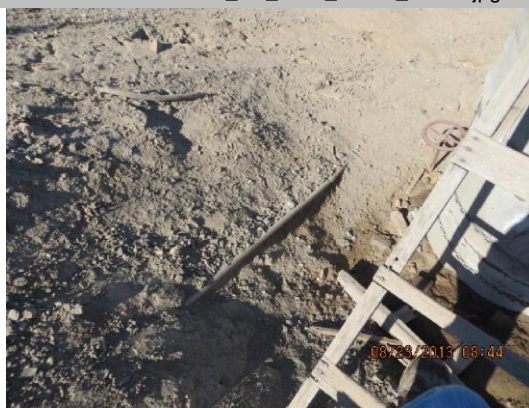
Photo 1 of 2 : UCIP_SP_2019_22069_37660.jpg

LM Start	4.17	Rating **	M	Issue No.	958
LM End	4.17	Issue Type +	En	Location *	
Category	Supplemental			GPS Latitude/Longitude	
				Start	End
Item	DWR UCIP Field Study			37.897074 °	37.897074 °
				-121.327926 °	-121.327926 °
DWR ID	24049				
Comment Code					
Inspector Comment					
FS_ID:22069 DS_ID:24049 EP_NO: N/A Repair Type: Non-Urgent Crossing Status: Found UCIP Comments: No permit identified for this crossing. FIELD_STRUCT_DESC: 2.25-inch polyvinyl chloride domestic water service line through the levee, 5 feet below the crown. Pump and tank on the waterside (WS) slope with a vent on the landside (LS) slope. FS Date: 8/23/2013

Pipe visible on LS slope.

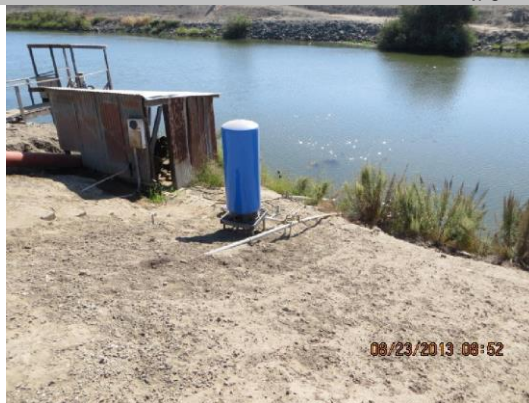
Photo 2 of 2 : UCIP_SP_2019_22069_37659.jpg

Pipe, pump, and tank visible on WS slope.

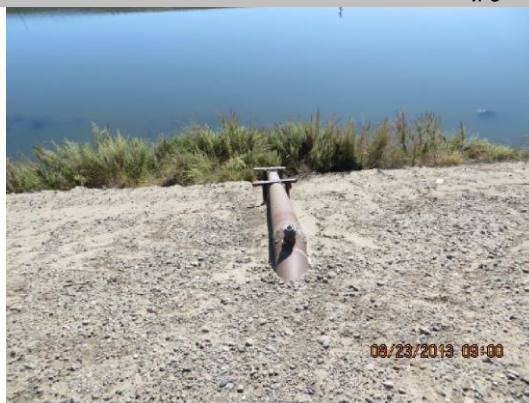
Photo 1 of 3 : UCIP_SP_2019_18320_30594.jpg

LM Start	4.37	Rating **	M	Issue No.	959
LM End	4.37	Issue Type +	En	Location *	
Category	Supplemental			GPS Latitude/Longitude	
				Start	End
Item	DWR UCIP Field Study			37.894453 °	37.894453 °
				-121.329232 °	-121.329232 °
DWR ID	20626				
Comment Code					
Inspector Comment					
FS_ID:18320 DS_ID:20626 EP_NO: N/A Repair Type: Non-Urgent Crossing Status: Found UCIP Comments: Small leak in pipe on LS slope and pipe slightly crushed on LS toe. FIELD_STRUCT_DESC: 9-inch steel pipe of unknown purpose through the levee, 3 feet below the crown. Pump in drainage ditch on the landside (LS). Siphon breaker on the waterside (WS) slope. [Additional Reference(s): DWR Levee Log, 2004. USACE San Joaquin O&M Manual 7, April 1964, (HLM 4.42) 8-inch pipe listed]. FS Date: 8/23/2013

Pipe and siphon breaker on WS slope.

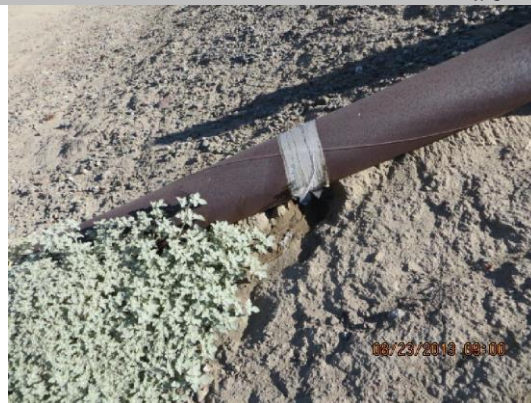
Photo 2 of 3 : UCIP_SP_2019_18320_30593.jpg

Small leak in pipe on LS slope.

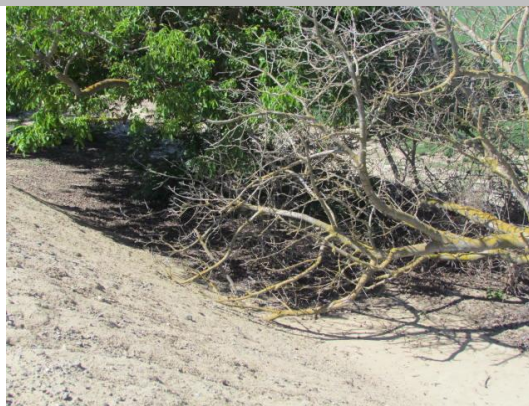
Photo 1 of 1 : SP_2019_RD0524_107_111_20190313_00139.jpg

LM Start	4.38	Rating **	M	Issue No.	111
LM End	4.38	Issue Type +	Ma	Location *	LS
Category	Earthen Levee			GPS Latitude/Longitude	
				Start	End
Item	Encroachments			37.894258 °	37.894258 °
				-121.329247 °	-121.329247 °
DWR ID	DWR_RD0524_01_s_2012_111				
Comment Code					
TR : Tree or limb					
Inspector Comment					
Dead tree at landside toe should be removed from levee toe.

Looking west at dead tree at landside toe.

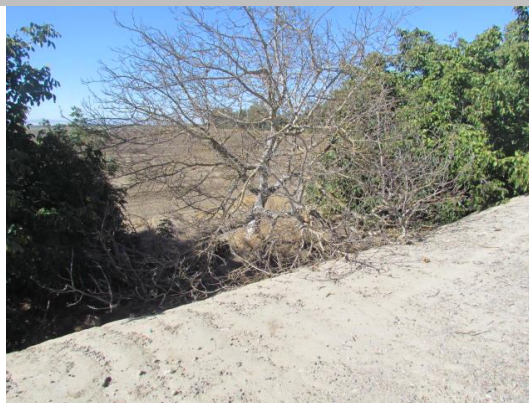
Photo 1 of 1 : SP_2019_RD0524_107_199_20190313_00206.jpg

LM Start	4.43	Rating **	M	Issue No.	199
LM End	4.43	Issue Type +	Ma	Location *	LS
Category	Earthen Levee			GPS Latitude/Longitude	
				Start	End
Item	Encroachments			37.893497 °	37.893497 °
				-121.329049 °	-121.329049 °
DWR ID	DWR_RD0524_01_f_2015_199				
Comment Code					
TR : Tree or limb					
Inspector Comment					
Remove dead tree from landside toe.

Looking west at dead tree on landward slope and toe fall 2015.

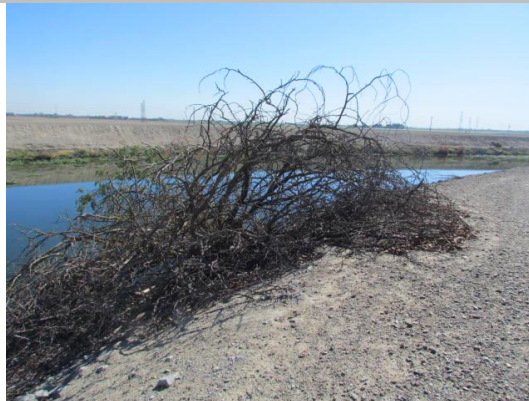
Photo 1 of 2 : SP_2019_RD0524_107_102_20190313_00134.jpg

LM Start	4.52	Rating **	U	Issue No.	102
LM End	4.52	Issue Type +	Ma	Location *	WS
Category	Earthen Levee			GPS Latitude/Longitude	
				Start	End
Item	Encroachments			37.892383 °	37.892383 °
				-121.328194 °	-121.328194 °
DWR ID	DWR_RD0524_01_f_2016_102				
Comment Code					
TR : Tree or limb					
Inspector Comment					
Dead tree on waterside slope.

Looking southeast at dead tree on waterside slope fall 2015

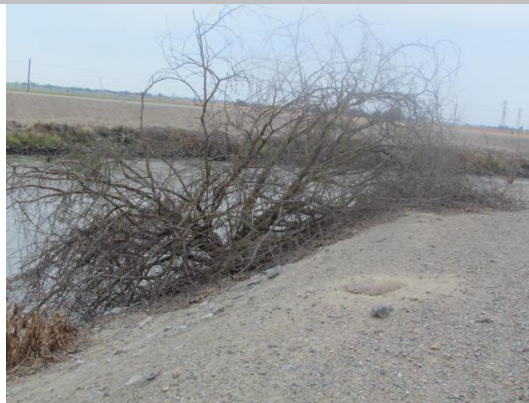
Photo 2 of 2 : SP_2019_RD0524_107_102_20190313_00135.jpg

Looking southeast at dead tree on waterside slope.

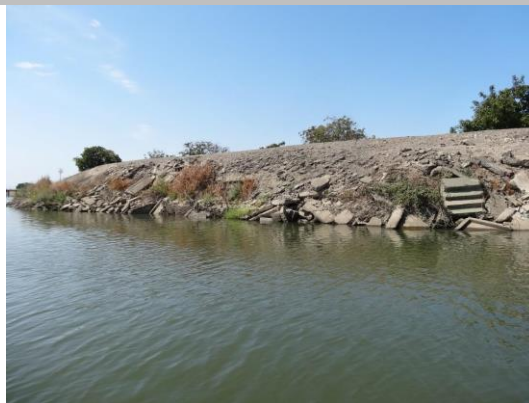
Photo 1 of 3 : SP_2019_RD0524_107_90_20190313_00120.jpg

LM Start	4.53	Rating **	A/W	Issue No.	90	
LM End	4.54	Issue Type +	Ma	Location *	WS	
Category	Supplemental			GPS Latitude/Longitude		
				Start	End	
Item	DWR Erosion Survey			37.892230 °	37.892230 °	
				-121.327930 °	-121.327930 °	
DWR ID	RD0524U01RM45.07					
Comment Code						
Inspector Comment						
09/13/2017: No significant change observed. 07/25/2016: No significant change observed. 06/24/2015: No significant change observed. 06/19/2014: No significant change observed. 08/13/2013: No significant change observed. 08/07/2012: The erosion is located at the inside of a river bend. Site is covered with broken concrete blocks and other debris. [2017 Site ID:RD0524U01RM45.07]

Front view of the erosion site.

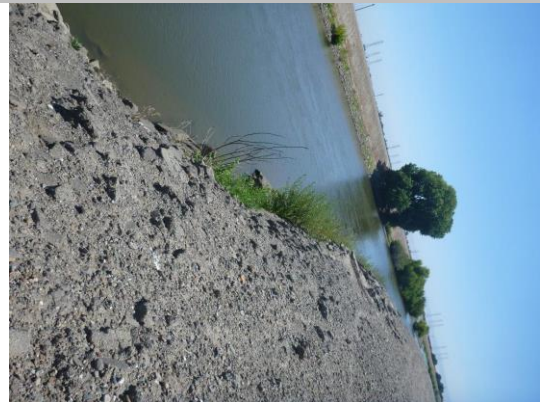
Photo 1 of 3 : LEVAL_SP_2019_468_2219.jpg

Comment Code					
Inspector Comment					
Levee Evaluation Comments					
Description:Slope protection repairs are needed along the waterside slope due to erosion. Based upon levee inspections, it was determined the waterside levee slopes were eroding, deteriorating and degrading in concave pocket sections at various locations along this levee reach. The eroded levee sections need to be restored back to design standards to prevent further deterioration of the damaged levee sections.					
Site ID No:468					
Site Designation:LMA-295					
Repair Type: Erosion					
Rating:Serious					
Field Date:7/26/2017					
Notes: Serious because erosion is impacting the levee, but there is some slope protection here. Slope is armored with asphalt and concrete rubble. The surrounding slopes are pretty baren, but there is a small bush within the site so it may be older.

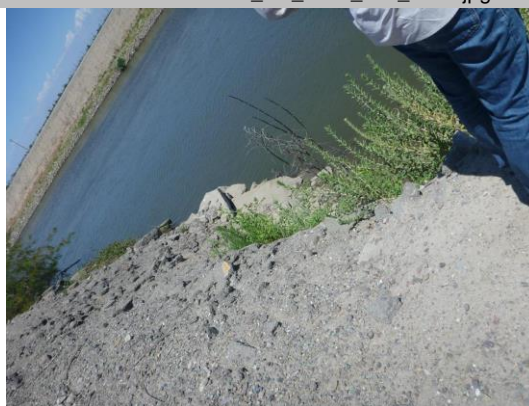
Photo 2 of 3 : LEVAL_SP_2019_468_2220.jpg

Item	2017 Storm Damage			37.892200 °	°					
				-121.328000 °	°					
DWR ID	DWR_RD0524_01_f_2017_235									
Comment Code										
Inspector Comment										
<p>Levee Evaluation Comments</p> <p>Description: Slope protection repairs are needed along the waterside slope due to erosion. Based upon levee inspections, it was determined the waterside levee slopes were eroding, deteriorating and degrading in concave pocket sections at various locations along this levee reach. The eroded levee sections need to be restored back to design standards to prevent further deterioration of the damaged levee sections.</p> <p>Site ID No: 468</p> <p>Site Designation: LMA-295</p> <p>Repair Type: Erosion</p> <p>Rating: Serious</p> <p>Field Date: 7/26/2017</p> <p>Notes: Serious because erosion is impacting the levee, but there is some slope protection here. Slope is armored with asphalt and concrete rubble. The surrounding slopes are pretty barren, but there is a small bush within the site so it may be older.</p>

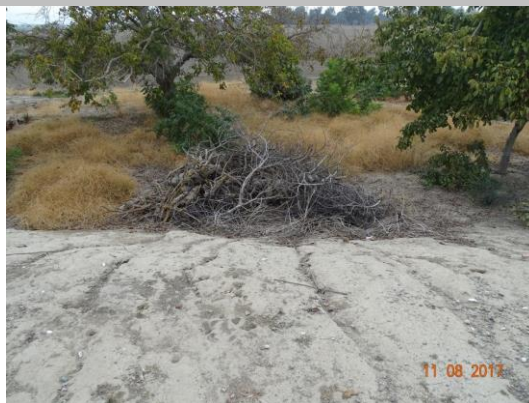
Photo 1 of 1 : SP_2019_RD0524_107_258_20190313_00269.jpg

LM Start	4.57	Rating **	M	Issue No.	258
LM End	4.57	Issue Type +	En	Location *	LS
Category	Earthen Levee			GPS Latitude/Longitude	
				Start	End
Item	Encroachments			37.891778 °	37.891778 °
				-121.328342 °	-121.328342 °
DWR ID	DWR_RD0524_01_f_2017_258				
Comment Code					
PR : Prunings					
Inspector Comment

Looking west at the landside slope.

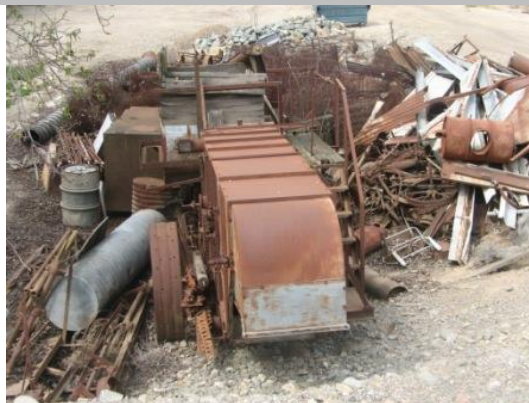
Photo 1 of 1 : SP_2019_RD0524_107_66_20190313_00092.jpg

LM Start	4.60	Rating **	M	Issue No.	66
LM End	4.60	Issue Type +	En	Location *	LS
Category	Earthen Levee			GPS Latitude/Longitude	
				Start	End
Item	Encroachments			37.891365 °	37.891365 °
				-121.328633 °	-121.328633 °
DWR ID	DWR_RD0524_01_s_2012_66				
Comment Code					
GA : Garbage					
Inspector Comment					
Old farm equipment at landside toe.

Garbage at landward toe next to ramp at LM 4.64

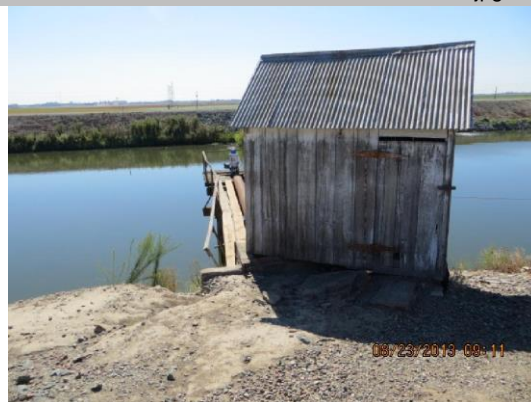
Photo 2 of 3 : UCIP_SP_2019_18323_30602.jpg

Pump on pier and slide gate house on WS shoulder.

Comment Code						
Inspector Comment						
FS_ID:18323						
DS_ID:20646						
EP_NO: 0						
Repair Type: Non-Urgent						
Crossing Status: Found						
UCIP Comments: Good candidate for video inspection as brick and mortar deteriorating inside tunnel.						
FIELD_STRUCT_DESC: 22-inch concrete irrigation pipe through the levee, 12 feet below the crown. Pump on pier at the waterside (WS) toe. 16-inch pipe from pump discharges into a concrete riser unit inside the pump house on the WS shoulder. Brick and mortar channel on the landside (LS) toe. [Additional Reference(s): USACE San Joaquin O&M Manual 7, April 1964, (HLM 4.73) 14-inch pipe listed].						
FS Date: 8/23/2013

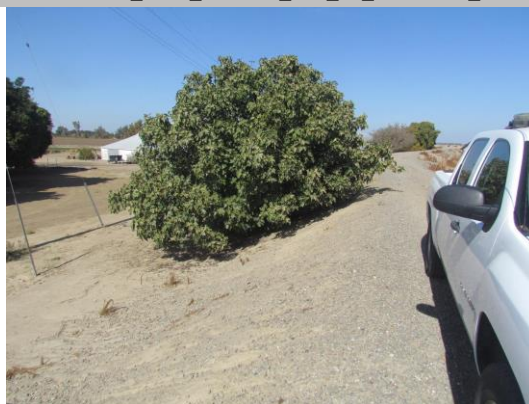
Photo 1 of 1 : SP_2019_RD0524_107_67_20190313_00093.jpg

LM Start	4.70	Rating **	M	Issue No.	67
LM End	4.70	Issue Type +	Ma	Location *	LS
Category	Earthen Levee			GPS Latitude/Longitude	
				Start	End
Item	Trim / Thin Trees			37.890108 °	37.890108 °
				-121.329523 °	-121.329523 °
DWR ID	DWR_RD0524_01_s_2012_67				
Comment Code					
T1 : Trim trees to at least five feet above ground level.					
Inspector Comment					
Fig tree at landside toe.

Looking northwest at untrimmed tree on landward slope.

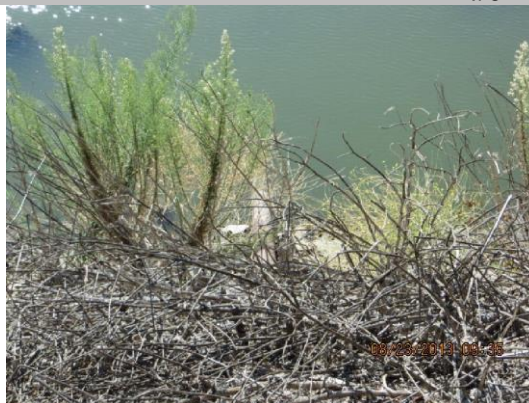
Photo 2 of 3 : UCIP_SP_2019_22728_38452.jpg

LM Start	4.89	Rating **	M	Issue No.	961 (cont)	
LM End	4.89	Issue Type +	En	Location *		
Category	Supplemental			GPS Latitude/Longitude		
				Start		End
Item	DWR UCIP Field Study			37.887694 °	37.887694 °	
				-121.331019 °	-121.331019 °	
DWR ID	20628					
Comment Code						
Inspector Comment						
FS_ID:22728 DS_ID:20628 EP_NO: 3817 Repair Type: Non-Urgent Crossing Status: Found UCIP Comments: Appears abandoned and if so should be done so properly. FIELD_STRUCT_DESC: *ABANDONED* 6-inch steel drainage pipe through the levee, 3 feet below the crown. Pump 120 feet off the landside (LS) toe. Siphon breaker in 24-inch corrugated metal riser unit on the waterside (WS) shoulder. (Permit No. 3817, 1961 - Ohm and Saunders). [Additional Reference(s): DWR Levee Log, 2004. USACE San Joaquin O&M Manual 7, April 1964, (HLM 4.95)]. FS Date: 8/23/2013

Pipe visible on WS toe.

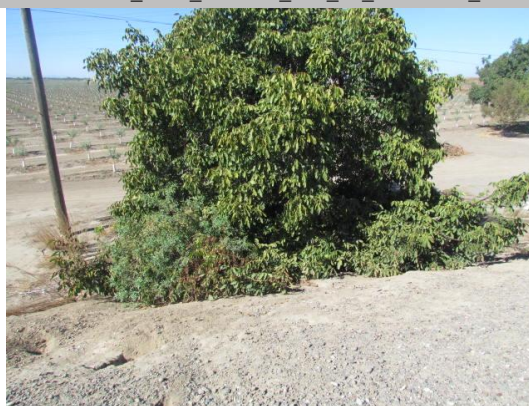
Photo 1 of 1 : SP_2019_RD0524_107_84_20190313_00116.jpg

LM Start	4.90	Rating **	M	Issue No.	84
LM End	4.93	Issue Type +	Ma	Location *	LS
Category	Earthen Levee			GPS Latitude/Longitude	
				Start	End
Item	Trim / Thin Trees			37.887613 °	37.887258 °
				-121.331161 °	-121.331596 °
DWR ID	DWR_RD0524_01_s_2012_84				
Comment Code					
T1 : Trim trees to at least five feet above ground level.					
Inspector Comment					
Untrimmed trees on landside slope.

Looking west at untrimmed tree on landward slope.

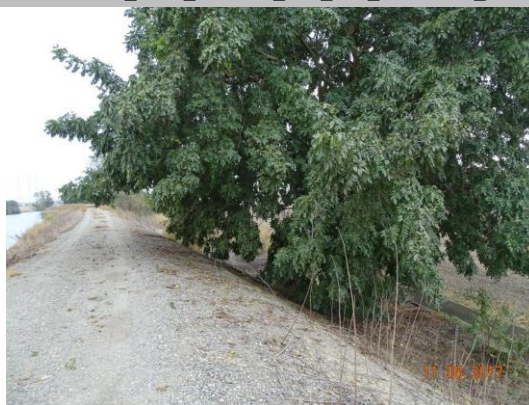
Photo 1 of 1 : SP_2019_RD0524_107_260_20190313_00270.jpg

LM Start	5.00	Rating **	M	Issue No.	260
LM End	5.00	Issue Type +	Ma	Location *	LS
Category	Earthen Levee			GPS Latitude/Longitude	
				Start	End
Item	Trim / Thin Trees			37.886367 °	37.886367 °
				-121.332047 °	-121.332047 °
DWR ID	DWR_RD0524_01_f_2017_260				
Comment Code					
T4 : Trim trees over roadway to at least 12 feet above ground level.					
Inspector Comment

Looking southwest at the landside slope.

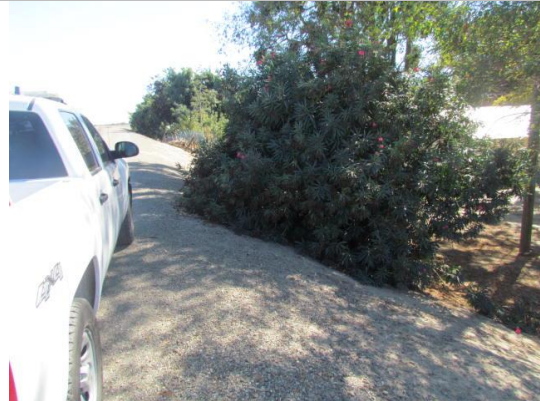
Photo 1 of 1 : SP_2019_RD0524_107_188_20190313_00191.jpg

LM Start	5.05	Rating **	M	Issue No.	188
LM End	5.07	Issue Type +	Ma	Location *	LS
Category	Earthen Levee			GPS Latitude/Longitude	
				Start	End
Item	Trim / Thin Trees			37.885673 °	37.885315 °
				-121.332122 °	-121.332139 °
DWR ID	DWR_RD0524_01_s_2014_188				
Comment Code					
T1 : Trim trees to at least five feet above ground level.					
Inspector Comment					
Untrimmed trees on landside slope and toe.

Looking south at oleander on landward slope.

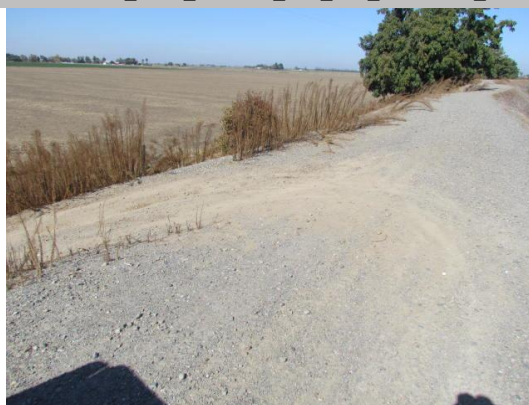
Photo 1 of 1 : SP_2019_RD0524_107_115_20190313_00144.jpg

LM Start	5.19	Rating **	M	Issue No.	115
LM End	5.19	Issue Type +	En	Location *	LS
Category	Earthen Levee			GPS Latitude/Longitude	
				Start	End
Item	Encroachments			37.883587 °	37.883587 °
				-121.332100 °	-121.332100 °
DWR ID	DWR_RD0524_01_s_2012_115				
Comment Code					
RA : Ramp					
Inspector Comment

Looking northwest at slope damage on landward slope.

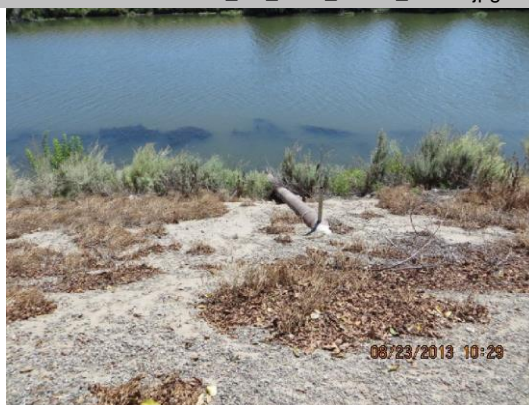
Photo 1 of 3 : UCIP_SP_2019_53358_30689.jpg

LM Start	5.41	Rating **	U	Issue No.	962	
LM End	5.41	Issue Type +	Ma	Location *		
Category	Supplemental			GPS Latitude/Longitude		
				Start		End
Item	DWR UCIP LMA Responsibility			37.880584 °	37.880584 °	
				-121.332901 °	-121.332901 °	
DWR ID	20630

Comment Code						
Inspector Comment						
FS_ID:53358						
DS_ID:20630						
EP_NO: N/A						
Repair Type: Urgent						
Crossing Status: Found						
UCIP Comments: 10/2/2018 Same as last inspection. Holes present in pipe pose a potential threat to levee's internal integrity. Recommend video inspection (D. Sanoski - DWR UCIP).11/16/2016 same as previous inspection hole in pipe is still present on WS near toe. This pipe does not appear to be in use. Need to contact owner to determine status of crossing. If the crossing is abandoned or still in use, owner will need to coordinate with the CVFPB to comply with Title 23 requirements. (O. Magana - DWR UCIP)08/23/2013 flap gate damage and does not work at WS toe. Large hole in pipe at WS toe. Pipe appears abandoned and should be done so properly. (W. Wylie - DWR UCIP)						
FIELD_STRUCT_DESC: *ABANDONED* 1 of 2: 12-inch steel irrigation pipe through the levee, 6 feet below the crown. Pump located on the waterside (WS), no pump found in 2013. Flap gate located on the WS end. [Additional Reference(s): DWR Levee Log, 2004. USACE San Joaquin O&M Manual 7, April 1964, (HLM 5.48) 10-inch pipe listed, Drawing No. 07-04-1490, Sheet 1490/4, (Station 8+01.3)].

Pipe visible on WS slope.

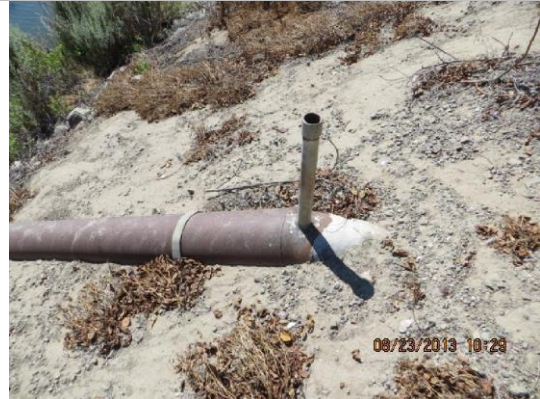
Photo 2 of 3 : UCIP_SP_2019_53358_30688.jpg

Comment Code						
Inspector Comment						
FS_ID:53358 DS_ID:20630 EP_NO: N/A Repair Type: Urgent Crossing Status: Found UCIP Comments: 10/2/2018 Same as last inspection. Holes present in pipe pose a potential threat to levee's internal integrity. Recommend video inspection (D. Sanoski - DWR UCIP).11/16/2016 same as previous inspection hole in pipe is still pressent on WS near toe. This pipe does not appear to be in use. Need to contact owner to determine status of crossing. If the crossing is abandoned or still in use, owner will need to coordinate with the CVFPB to comply with Title 23 requirements. (O. Magana - DWR UCIP)08/23/2013 flap gate damage and does not work at WS toe. Large hole in pipe at WS toe. Pipe appears abandoned and should be done so properly. (W. Wylie - DWR UCIP) FIELD_STRUCT_DESC: *ABANDONED* 1 of 2: 12-inch steel irrigation pipe through the levee, 6 feet below the crown. Pump located on the waterside (WS), no pump found in 2013. Flap gate located on the WS end. [Additional Reference(s): DWR Levee Log, 2004. USACE San Joaquin O&M Manual 7, April 1964, (HLM 5.48) 10-inch pipe listed, Drawing No. 07-04-1490, Sheet 1490/4, (Station 8+01.3)]. FS Date: 10/2/2018 1:34:00 PM

Vent on pipe on WS slope. Possible slurry standpipe that has not yet been used.

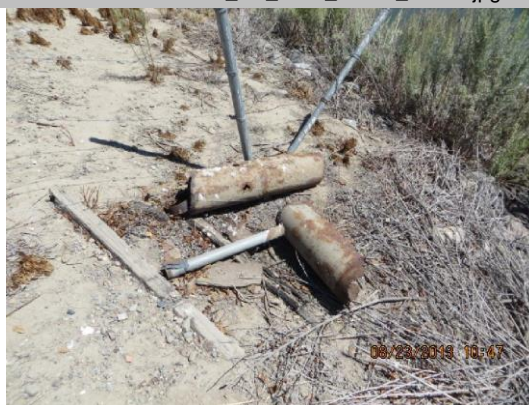
Photo 1 of 3 : UCIP_SP_2019_18348_30706.jpg

LM Start	5.42	Rating **	M	Issue No.	963
LM End	5.42	Issue Type +	Ma	Location *	
Category	Supplemental			GPS Latitude/Longitude	
				Start	End
Item	DWR UCIP LMA Responsibility			37.880358 °	37.880358 °
				-121.332972 °	-121.332972 °
DWR ID	20631				
Comment Code					
Inspector Comment					
FS_ID:18348 DS_ID:20631 EP_NO: N/A Repair Type: Non-Urgent Crossing Status: Found UCIP Comments: Recent work being done on WS slope. Pipe may still be in use. FIELD_STRUCT_DESC: 10-inch steel drainage pipe through the levee, 6 feet below the crown. Pump not found on the landside (LS). [Additional Reference(s): DWR Levee Log, 2004. USACE San Joaquin O&M Manual 7, April 1964, (HLM 5.50)]. FS Date: 8/23/2013

10-inch pipe debris on the WS slope.

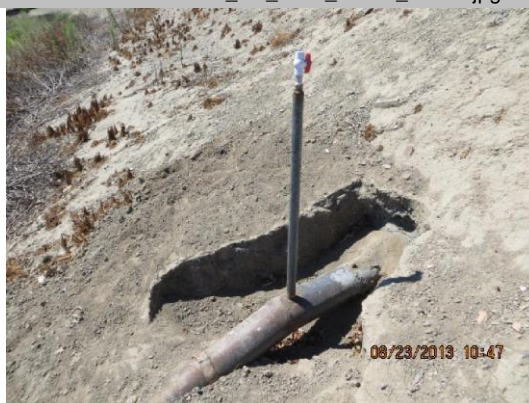
Photo 2 of 3 : UCIP_SP_2019_18348_30705.jpg

LM Start	5.42	Rating **	M	Issue No.	963 (cont)	
LM End	5.42	Issue Type +	Ma	Location *		
Category	Supplemental			GPS Latitude/Longitude		
				Start	End	
Item	DWR UCIP LMA Responsibility			37.880358 °	37.880358 °	
				-121.332972 °	-121.332972 °	
DWR ID	20631					
Comment Code						
Inspector Comment						
FS_ID:18348						
DS_ID:20631						
EP_NO: N/A						
Repair Type: Non-Urgent						
Crossing Status: Found						
UCIP Comments: Recent work being done on WS slope. Pipe may still be in use.						
FIELD_STRUCT_DESC: 10-inch steel drainage pipe through the levee, 6 feet below the crown. Pump not found on the landside (LS).						
[Additional Reference(s): DWR Levee Log, 2004. USACE San Joaquin O&M Manual 7, April 1964, (HLM 5.50)].						
FS Date: 8/23/2013

8-inch pipe sleeved through 10-inch pipe with vent on WS slope.

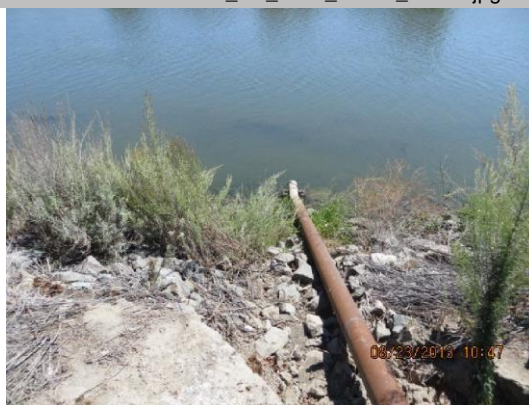
Photo 3 of 3 : UCIP_SP_2019_18348_30704.jpg

No flap gate on end of pipe at WS toe.

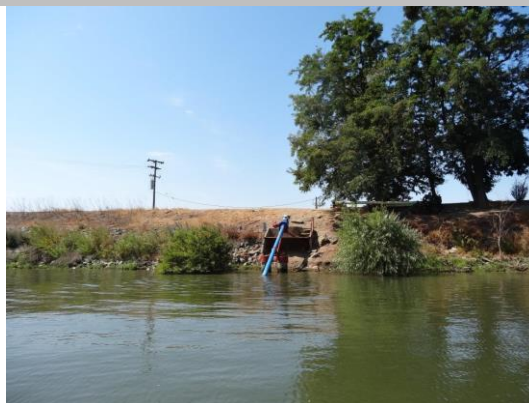
Photo 1 of 2 : SP_2019_RD0524_107_92_20190313_00123.jpg

LM Start	5.53	Rating **	M	Issue No.	92
LM End	5.53	Issue Type +	Ma	Location *	WS
Category	Supplemental			GPS Latitude/Longitude	
				Start	End
Item	DWR Erosion Survey			37.878920 °	37.878920 °
				-121.332670 °	-121.332670 °
DWR ID	RD0524U01RM46.06				
Comment Code					
Inspector Comment					
09/13/2017: No significant change observed.					
07/25/2016: No significant change observed.					
06/24/2015: No significant change observed.					
06/19/2014: No significant change observed.					
08/13/2013: Larger trees are at the levee shoulder, and an irrigation pump station is next to the erosion site. [2017 Site ID:RD0524U01RM46.06]

Front view of the erosion.

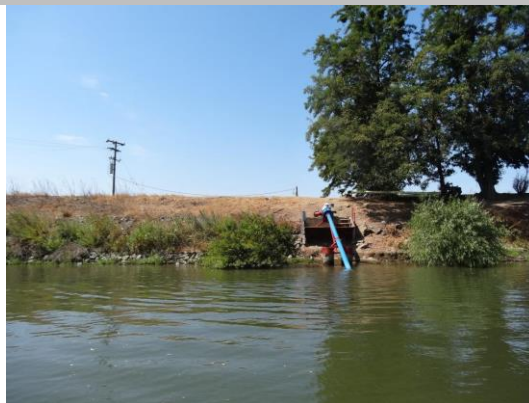
Photo 2 of 2 : SP_2019_RD0524_107_92_20190313_00124.jpg

LM Start	5.53	Rating **	M	Issue No.	92 (cont)	
LM End	5.53	Issue Type +	Ma	Location *	WS	
Category	Supplemental			GPS Latitude/Longitude		
				Start	End	
Item	DWR Erosion Survey			37.878920 °	37.878920 °	
				-121.332670 °	-121.332670 °	
DWR ID	RD0524U01RM46.06					
Comment Code						
Inspector Comment						
09/13/2017: No significant change observed.						
07/25/2016: No significant change observed.						
06/24/2015: No significant change observed.						
06/19/2014: No significant change observed.						
08/13/2013: Larger trees are at the levee shoulder, and an irrigation pump station is next to the erosion site. [2017 Site ID:RD0524U01RM46.06]

Close view of the site.

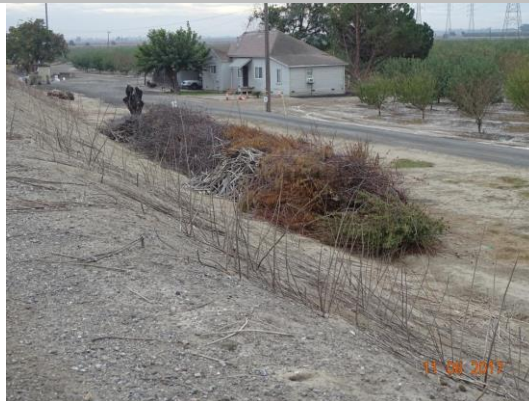
Photo 1 of 2 : SP_2019_RD0524_107_175_20190313_00177.jpg

LM Start	5.70	Rating **	U	Issue No.	175
LM End	5.70	Issue Type +	En	Location *	LS
Category	Earthen Levee			GPS Latitude/Longitude	
				Start	End
Item	Encroachments			37.876417 °	37.876417 °
				-121.332505 °	-121.332505 °
DWR ID	DWR_RD0524_01_s_2017_175				
Comment Code					
PR : Prunings					
Inspector Comment

Looking southwest at the landside slope.

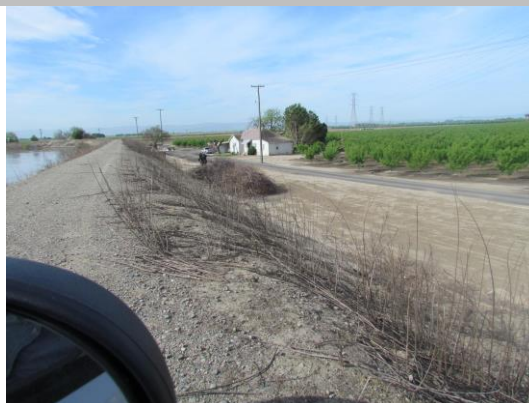
Photo 2 of 2 : SP_2019_RD0524_107_175_20190313_00178.jpg

Looking south at large pruning pile at landward toe.

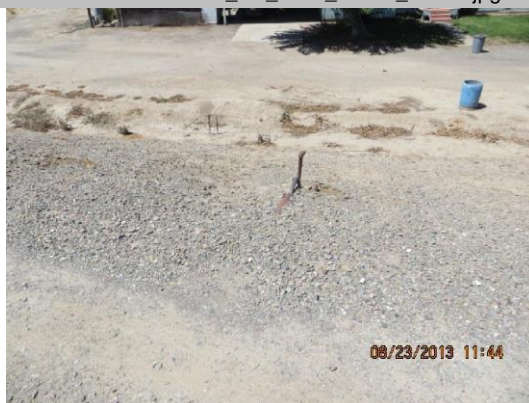
Photo 1 of 2 : UCIP_SP_2019_18364_30761.jpg

LM Start	5.74	Rating **	M	Issue No.	964	
LM End	5.74	Issue Type +	En	Location *		
Category	Supplemental			GPS Latitude/Longitude		
				Start	End	
Item	DWR UCIP Field Study			37.876001 °	37.876001 °	
				-121.332725 °	-121.332725 °	
DWR ID	20649					
Comment Code						
Inspector Comment						
FS_ID:18364 DS_ID:20649 EP_NO: N/A Repair Type: Non-Urgent Crossing Status: Found UCIP Comments: Abandoned and should be done so properly. FIELD_STRUCT_DESC: 2.25-inch steel conduit for a 1-inch plastic electrical conduit through the levee, 0.25 feet below the crown. Lines exposed on both slopes. [Additional Reference(s): DWR Levee Log, 2004]. FS Date: 8/23/2013

Steel conduit and electrical conduit visible on the LS shoulder.

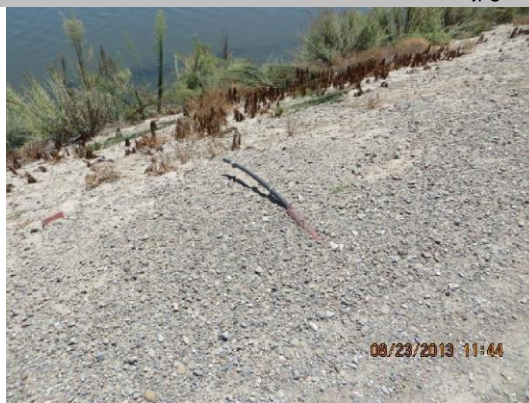
Photo 2 of 2 : UCIP_SP_2019_18364_30760.jpg

Steel conduit and electrical conduit visible on the WS shoulder.

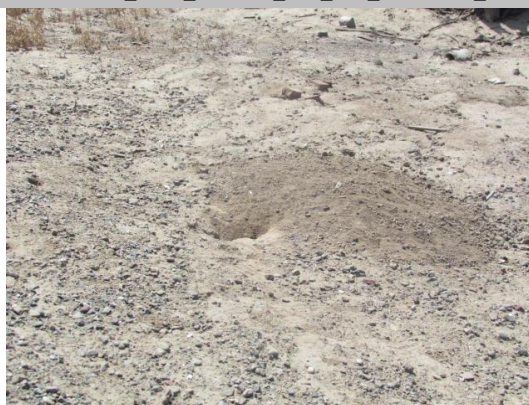
Photo 1 of 2 : SP_2019_RD0524_107_197_20190313_00201.jpg

LM Start	5.77	Rating **	A/W	Issue No.	197
LM End	5.79	Issue Type +	Ma	Location *	LS
Category	Earthen Levee			GPS Latitude/Longitude	
				Start	End
Item	Animal Control			37.875545 °	37.875310 °
				-121.332952 °	-121.333065 °
DWR ID	DWR_RD0524_01_s_2015_197				
Comment Code					
A1 : Exterminate rodents and backfill and compact or grout burrows.					
Inspector Comment					
Several rodent holes on landside slope and levee crown. LMA Backfilled hole but no rodent control measures are in place.

Looking north at typical view of rodent holes on landward slope.

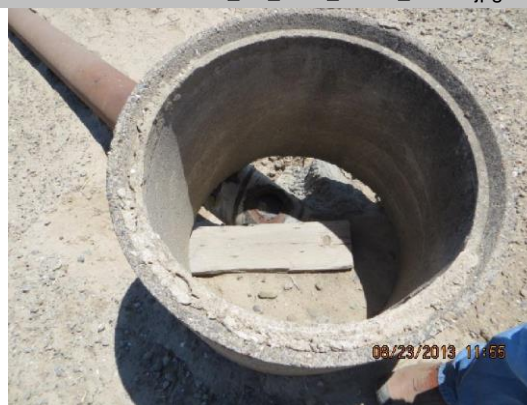
Photo 1 of 2 : UCIP_SP_2019_18369_30785.jpg

Comment Code						
Inspector Comment						
FS_ID:18369 DS_ID:20636 EP_NO: N/A Repair Type: Non-Urgent Crossing Status: Found UCIP Comments: Apparent leak on WS shoulder at concrete riser. Erosion under pipe. This may have been fixed when the pipe was sleeved with a PVC liner. FIELD_STRUCT_DESC: 10-inch steel drainage pipe through the levee, 5 feet below the crown. Pump on the landside (LS). Siphon breaker in a 36-inch concrete riser unit on the waterside (WS) shoulder. Power pole at the LS toe. Polyvinyl chloride liner sleeved inside steel pipe. [Additional Reference(s): DWR Levee Log, 2004. USACE San Joaquin O&M Manual 7, April 1964, (HLM 5.88)]. FS Date: 8/23/2013

Concrete standpipe over pipe on WS shoulder.

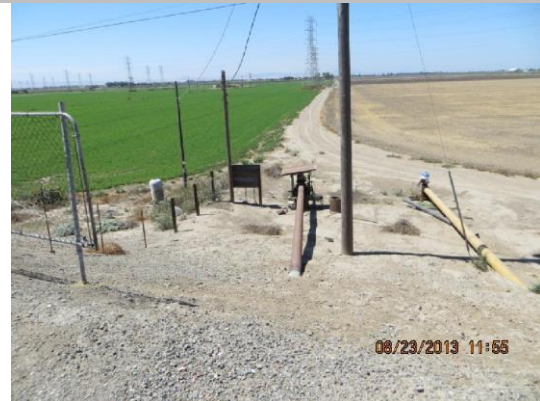
Photo 2 of 2 : UCIP_SP_2019_18369_30784.jpg

Pipe, pump, power pole, and meter off LS toe.

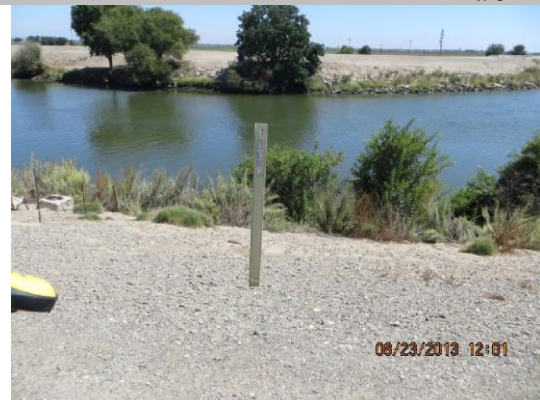
Photo 1 of 1 : UCIP_SP_2019_18705_31249.jpg

LM Start	5.82	Rating **	M	Issue No.	967
LM End	5.82	Issue Type +	En	Location *	
Category	Supplemental			GPS Latitude/Longitude	
				Start	End
Item	DWR UCIP Field Study			37.874829 °	37.874829 °
				-121.333265 °	-121.333265 °
DWR ID	20656				
Comment Code					
Inspector Comment					
FS_ID:18705 DS_ID:20656 EP_NO: N/A Repair Type: Non-Urgent Crossing Status: Indicator Found UCIP Comments: Need to verify gasline exists and if so improve signage. FIELD_STRUCT_DESC: Gas line marker sign on the waterside (WS) shoulder. FS Date: 8/23/2013

Gasline marker on WS shoulder.

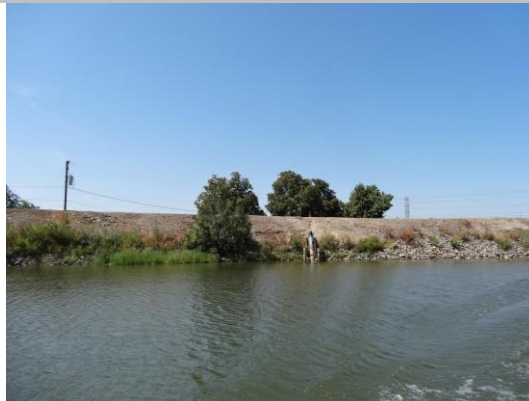
Photo 1 of 2 : SP_2019_RD0524_107_93_20190313_00125.jpg

LM Start	5.86	Rating **	U	Issue No.	93
LM End	5.86	Issue Type +	Ma	Location *	WS
Category	Supplemental			GPS Latitude/Longitude	
				Start	End
Item	DWR Erosion Survey			37.874370 °	37.874370 °
				-121.332850 °	-121.332850 °
DWR ID	RD0524U01RM46.39				
Comment Code					
Inspector Comment					
09/13/2017: No significant change observed.					
07/25/2016: No significant change observed.					
06/24/2015: No significant change observed.					
06/19/2014: No significant change observed.					
08/13/2013: No significant change observed.					
08/07/2012: The erosion is near a water-intake structure. Pipe leakage likely caused the erosion. [2017 Site ID:RD0524U01RM46.39]

Front view of the site.

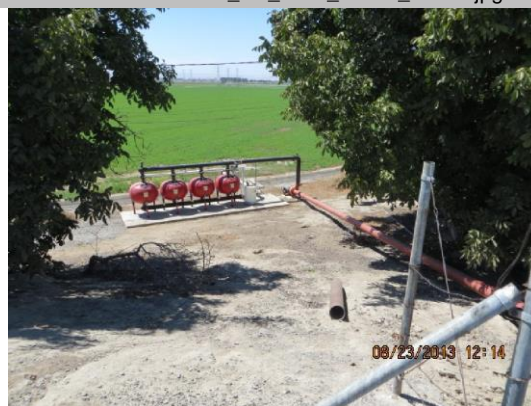
Photo 3 of 3 : UCIP_SP_2019_18379_30827.jpg

Comment Code						
Inspector Comment						
FS_ID:18379						
DS_ID:20638						
EP_NO: N/A						
Repair Type: Non-Urgent						
Crossing Status: Found						
UCIP Comments: Heavy erosion around pipe upstream of standpipe on LS slope. Verify pipe is not leaking and repair erosion on LS slope.						
FIELD_STRUCT_DESC: 12-inch steel irrigation pipe through the levee, 10 feet below the crown. Slant pump on pier at the waterside (WS) toe.						
10-inch steel standpipe on the landside (LS) slope. 42-inch concrete standpipe on the LS slope. Filter plant and power pole on the LS toe.

Filter pump on LS toe.
